ASRF Australian Street Rod Federation TAC

ADVICE SHEET 4-19 78/7/2019

Update re - Ductile Cast Iron Spindles/Stub axles and Perch Bolts

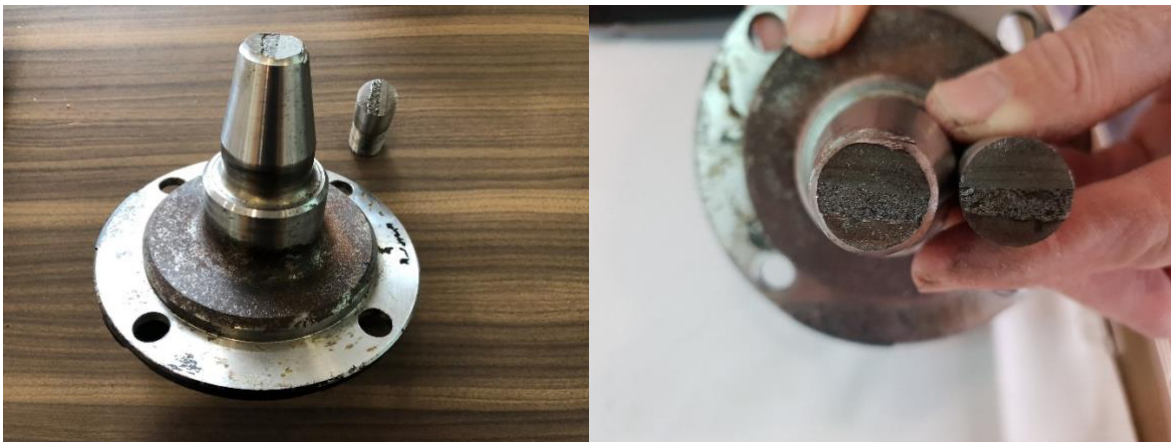
The ASRF TAC Committee have now examined an SG cast iron spindle which just lately failed on a Street Rod in the Sydney area.

Luckily the vehicle was being parked when the spindle broke. The wheel fell over and was restrained by the disc brake /caliper with some consequent damage to the brake parts. Had the car been at highway speeds there would have been every chance of a locked-up wheel and a spin off the road into a tree or oncoming traffic.

As the photos show the spindle (being made from a brittle material) initially showed fatigue cracking at the top and bottom which progressed through until the remaining section broke away. The vehicle has apparently been on the road for some years. This is totally typical of what happens with this type of casting, there being no warning by way of any bending, just the cracks silently growing larger with continued use until total sudden separation occurs.

Whilst there is no visual way for a layman be sure if you have an inferior SG iron part or a quality Forged Steel item there are a couple of tests that, whilst leaving small evidence marks, wont make the spindle unsafe should it prove to be steel.

The first is to drill a small 3 or 4 mm hole in a non-stressed section such as the outer flange or top boss of the kingpin near the grease nipple. Steel swarf will come off in a spiral. Cast iron will come off in crumbled small pieces. You only need to drill a few mm deep to see what you have. If testing a Perch bolt you could drill in the end where the thread is.

Another test is to take a sander or grinder to the part, again near the top of a spindle or the end of the perch. Steel gives off a white spark in a straight line, cast iron gives off a more orange spark which curves downwards. If not sure maybe practice on some scrap steel and cast iron to get an idea of what to expect.

Therefore the ASRF TAC again advises that ALL SG Cast Iron Spindles and Perch Bolts are unacceptable for Australian Street Rod use. If you have purchased these from any source we recommend you do not use them, or if fitted do not drive the vehicle until they are replaced with items known to be of a ductile material such as Forged Steel or Stainless Steel. Please note that Australian made 28-48 Ford beam axle Spindles and of course Genuine Ford parts are not in question. At this time Superbell and Speedway parts are suspect but other resellers may have sourced from the same factory under different names so trust no one, particularly the guys who try to cut their losses at a swap meet.
